PRODUCT RECALLS

Product Safety Information Notice on Shimano pre-July 2019 11-speed HOLLOWTECH II road cranksets

📅 OCTOBER 26, 2023

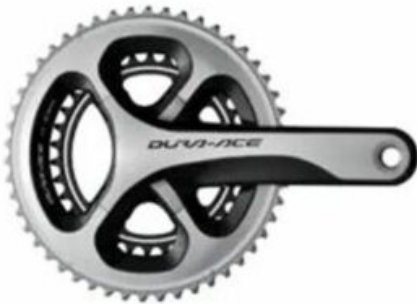
DURA-ACE FC-9000

The potential risk presented by these products is injuries. Reports received by Shimano indicate that the outer cover of the crank arm may start to separate from the main crank body, posing potential fall and injury hazards to consumers.

Customers who believe they have an affected product should go to an authorised Shimano dealer who will inspect and change the crankarm if required for no charge. Customers can check their local dealer [here](#).

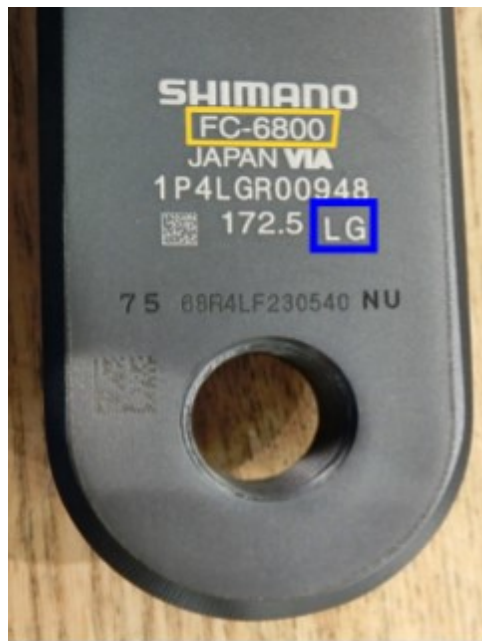
The production code and model number are stamped on the inside of the crank arm near the bottom of the arm.

Customers are advised to check the inside of the crank arm to see if their product is affected (see the consumer notice for the exact steps in this regard).
