PRODUCT RECALLS

Specialized Bicycle Components recalls headlights and taillights

MAY 11, 2016

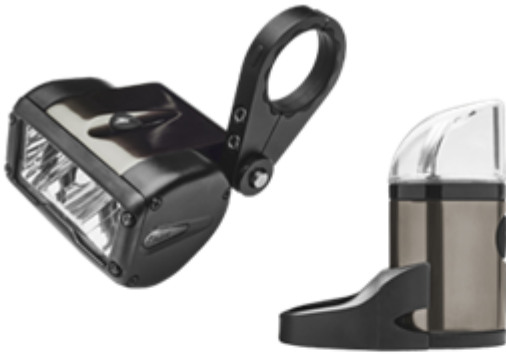
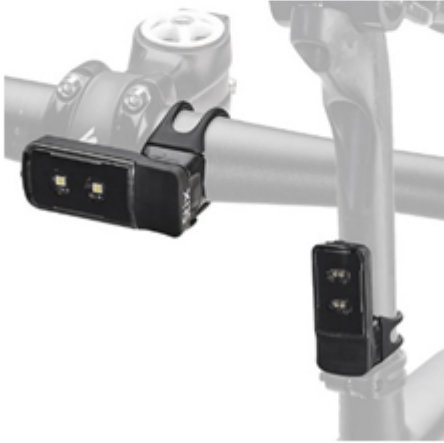
Flux bicycle lights

Due to a potential fire and burn hazards, Specialized Bicycle Components have initiated a product recall for Specialized Flux and Stix Sport and Comp model bicycle headlights and taillights.

Specialized Bicycle Components advice is that, consumers should immediately stop using these recalled headlights and taillights. Return them an authorised Specialized Bicycle retailer for a free repair for Flux model headlights, or a free replacement.
