PRODUCT RECALLS

Product Safety Information Notice on Caple Gas Hobs, Gas Supply Elbow Joint

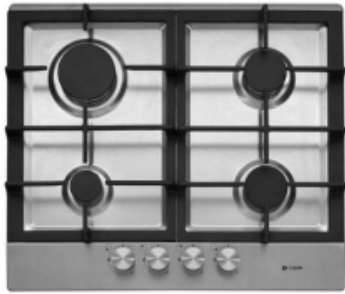
C749G

The gas supply elbow joint from the gas hob to the gas supply may fracture, which can cause gas to leak through the fracture. This presents a risk of burns, fire, explosion and poisoning from inhalation which could pose a risk to health, or even death.

It is vitally important that consumers do not use their gas hob. The gas hobs above must be urgently inspected and modified. This will be conducted free of charge by a Registered Gas Installer.
